Management Survey (with MA and PA)

58 Craymill Square Dartford
DA1 4SF

Asbestos Gone
Asbestos Gone Yard
Royal Eagle Close
Rochester
Kent
ME2 4NF

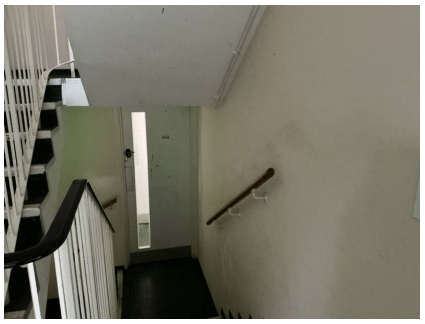
Survey Date:	Lead Surveyor	Survey Type	Floor
21 Oct 2026	James Bullen	Management Survey	1st Floor
Building	**Room**	**Item**	**Quantity**
Main	Com Area 1 101	Textured coating Walls	30mÂ²
Sample No (S,SP,P,As,Na)	**Product Type**	**Surface Treatment**	**Condition**
As CS002882 (SP)	N/A	N/A	N/A
Analysis		**Accessibility**	
No Asbestos Detected		N/A

Normal Occupancy	Score	Likelihood of disturbance	Score	Exposure Potential	Score	Maintenance Activity	Score
Main type of activity	N/A	Location	N/A	Number of occupants	N/A	Type of Maintenance	N/A
		Accessibility	N/A	Frequency of use	N/A	Frequency of maintenance	N/A
		Amount	N/A	Average Time	N/A		
Average Score	N/A	Average Score	N/A	Average Score	N/A	Average Score	N/A
Average of Priority	N/A						
Material Assessment Score	N/A						
Recommendation	No further action required

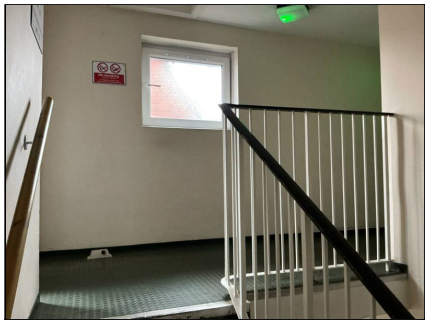
Survey Date:	Lead Surveyor	Survey Type	Floor
21 Oct 2026	James Bullen	Management Survey	2nd Floor
Building	**Room**	**Item**	**Quantity**
Main	Com Area 1 201	Textured coating Walls	30mÂ²
Sample No (S,SP,P,As,Na)	**Product Type**	**Surface Treatment**	**Condition**
As CS002882 (SP)	N/A	N/A	N/A
Analysis		**Accessibility**	
No Asbestos Detected		N/A

Normal Occupancy	Score	Likelihood of disturbance	Score	Exposure Potential	Score	Maintenance Activity	Score
Main type of activity	N/A	Location	N/A	Number of occupants	N/A	Type of Maintenance	N/A
		Accessibility	N/A	Frequency of use	N/A	Frequency of maintenance	N/A
		Amount	N/A	Average Time	N/A		
Average Score	N/A	Average Score	N/A	Average Score	N/A	Average Score	N/A
Average of Priority	N/A						
Material Assessment Score	N/A						
Recommendation	No further action required

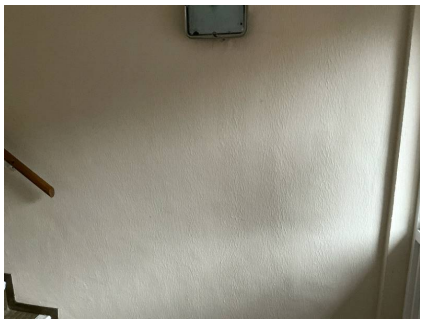
Survey Date:	Lead Surveyor	Survey Type	Floor
21 Oct 2026	James Bullen	Management Survey	Ground Floor
Building	**Room**	**Item**	**Quantity**
Main	Com Area 2 G02	Textured coating Walls	30mÂ²
Sample No (S,SP,P,As,Na)	**Product Type**	**Surface Treatment**	**Condition**
CS002883 (S)	N/A	N/A	N/A
Analysis		**Accessibility**	
No Asbestos Detected		N/A

Normal Occupancy	Score	Likelihood of disturbance	Score	Exposure Potential	Score	Maintenance Activity	Score
Main type of activity	N/A	Location	N/A	Number of occupants	N/A	Type of Maintenance	N/A
		Accessibility	N/A	Frequency of use	N/A	Frequency of maintenance	N/A
		Amount	N/A	Average Time	N/A		
Average Score	N/A	Average Score	N/A	Average Score	N/A	Average Score	N/A
Average of Priority	N/A						
Material Assessment Score	N/A						
Recommendation	No further action required

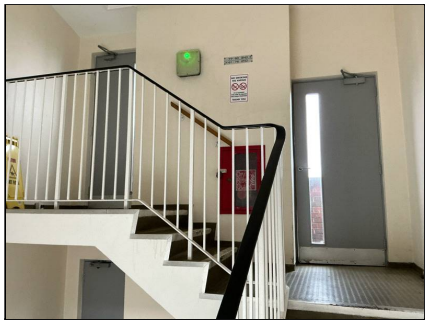
Survey Date:	Lead Surveyor	Survey Type	Floor
21 Oct 2026	James Bullen	Management Survey	2nd Floor
Building	**Room**	**Item**	**Quantity**
Main	Com Area 2 202	Textured coating Walls	20mÂ²
Sample No (S,SP,P,As,Na)	**Product Type**	**Surface Treatment**	**Condition**
As CS002883 (SP)	N/A	N/A	N/A
Analysis		**Accessibility**	
No Asbestos Detected		N/A

Normal Occupancy	Score	Likelihood of disturbance	Score	Exposure Potential	Score	Maintenance Activity	Score
Main type of activity	N/A	Location	N/A	Number of occupants	N/A	Type of Maintenance	N/A
		Accessibility	N/A	Frequency of use	N/A	Frequency of maintenance	N/A
		Amount	N/A	Average Time	N/A		
Average Score	N/A	Average Score	N/A	Average Score	N/A	Average Score	N/A
Average of Priority	N/A						
Material Assessment Score	N/A						
Recommendation	No further action required

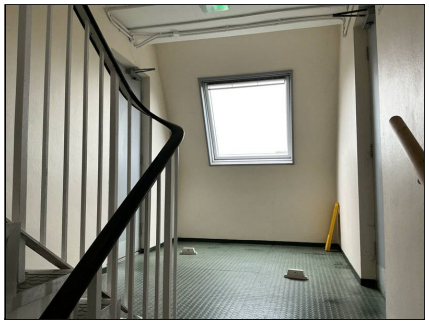
Survey Date:	Lead Surveyor	Survey Type	Floor
21 Oct 2026	James Bullen	Management Survey	1st Floor
Building	**Room**	**Item**	**Quantity**
Main	Com Area 3 103	Textured coating Walls	20mÂ²
Sample No (S,SP,P,As,Na)	**Product Type**	**Surface Treatment**	**Condition**
As CS002884 (SP)	N/A	N/A	N/A
Analysis		**Accessibility**	
No Asbestos Detected		N/A

Normal Occupancy	Score	Likelihood of disturbance	Score	Exposure Potential	Score	Maintenance Activity	Score
Main type of activity	N/A	Location	N/A	Number of occupants	N/A	Type of Maintenance	N/A
		Accessibility	N/A	Frequency of use	N/A	Frequency of maintenance	N/A
		Amount	N/A	Average Time	N/A		
Average Score	N/A	Average Score	N/A	Average Score	N/A	Average Score	N/A
Average of Priority	N/A						
Material Assessment Score	N/A						
Recommendation	No further action required

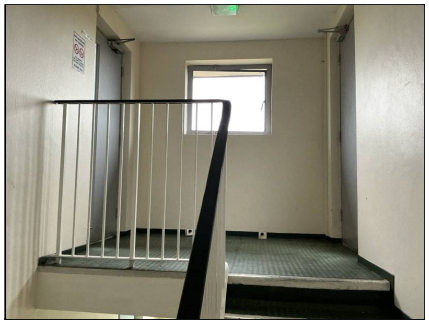
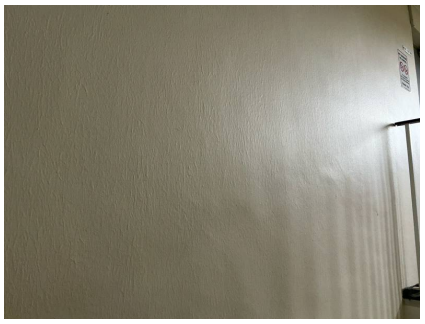
Survey Date:	Lead Surveyor	Survey Type	Floor
21 Oct 2026	James Bullen	Management Survey	2nd Floor
Building	**Room**	**Item**	**Quantity**
Main	Com Area 3 203	Textured coating Walls	20mÂ²
Sample No (S,SP,P,As,Na)	**Product Type**	**Surface Treatment**	**Condition**
As CS002884 (SP)	N/A	N/A	N/A
Analysis		**Accessibility**	
No Asbestos Detected		N/A

Normal Occupancy	Score	Likelihood of disturbance	Score	Exposure Potential	Score	Maintenance Activity	Score
Main type of activity	N/A	Location	N/A	Number of occupants	N/A	Type of Maintenance	N/A
		Accessibility	N/A	Frequency of use	N/A	Frequency of maintenance	N/A
		Amount	N/A	Average Time	N/A		
Average Score	N/A	Average Score	N/A	Average Score	N/A	Average Score	N/A
Average of Priority	N/A						
Material Assessment Score	N/A						
Recommendation	No further action required

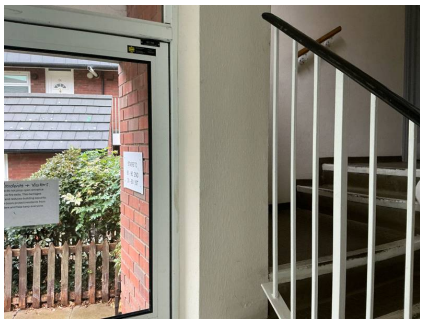
Survey Date:	Lead Surveyor	Survey Type	Floor
21 Oct 2026	James Bullen	Management Survey	Ground Floor
Building	**Room**	**Item**	**Quantity**
Main	Com Area 4 G04	Textured coating Walls	20mÂ²
Sample No (S,SP,P,As,Na)	**Product Type**	**Surface Treatment**	**Condition**
CS002885 (S)	N/A	N/A	N/A
Analysis		**Accessibility**	
No Asbestos Detected		N/A

Normal Occupancy	Score	Likelihood of disturbance	Score	Exposure Potential	Score	Maintenance Activity	Score
Main type of activity	N/A	Location	N/A	Number of occupants	N/A	Type of Maintenance	N/A
		Accessibility	N/A	Frequency of use	N/A	Frequency of maintenance	N/A
		Amount	N/A	Average Time	N/A		
Average Score	N/A	Average Score	N/A	Average Score	N/A	Average Score	N/A
Average of Priority	N/A						
Material Assessment Score	N/A						
Recommendation	No further action required
